# Assessment of wind speeds based on damage observations from the Angus (Ontario) Tornado of 17 June 2014

**Abstract:** A tornado occurred in Angus, Ontario, during the late afternoon hours of 17 June 2014. The authors conducted a damage investigation on the morning following the storm. The damage indicators support the classification of the tornado as an EF-2 on the Enhanced Fujita Scale, including the observation of several complete roof failures of recently-constructed, wood-frame houses. Most of the damage to residential homes was contained along two streets, with the tornado appearing to have gone down the backyards between the two. In total, 101 houses were observed to have sustained some level of damage. The evidence suggests that the quality of construction likely affected the performance of failed roofs. A detailed fragility analysis was conducted to assess wind speeds associated with these failures of the roof-to-wall connections. An overturned and lofted box truck provided the opportunity to correlate this failure with adjacent, repetitive failures of roof sheathing, shingles, and garage doors.

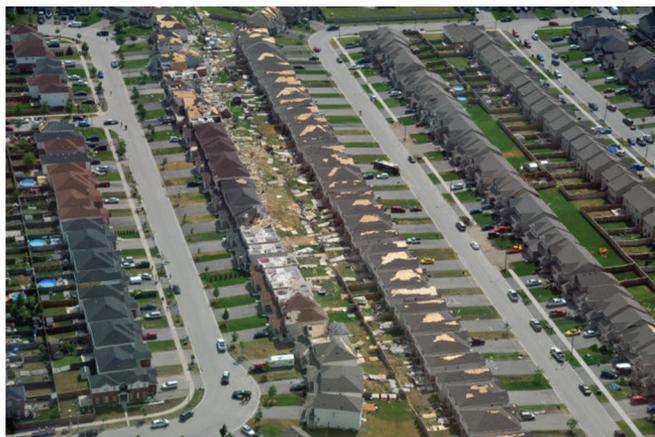
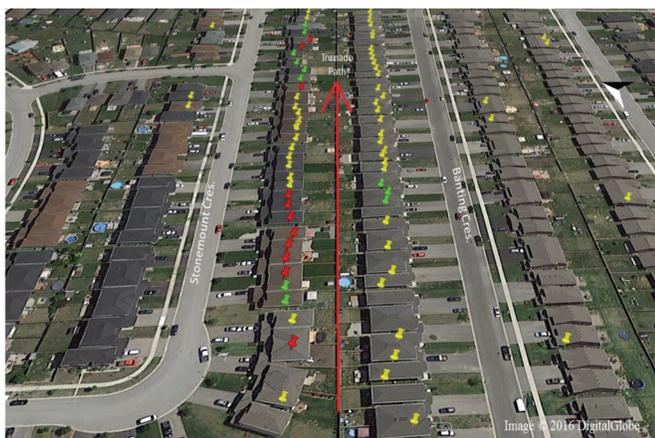
Figure 1 shows the survey area within Angus and the locations of houses with damage. Much of the damage was located on two streets, Stonemount Cres. and Banting Cres., and that away from these two streets there was only scattered, light damage. The aerial photograph in Fig. 1a shows this clearly. In total, 101 houses were identified with visible damage. Figure 1 also shows that there were 11 houses that lost their roofs, and that these were located in close proximity to each other on Stonemount Cres. In addition, many (eight) of the roof sheathing failures occurred close to these complete roof failures on Stonemount Cres., with only three sheathing failures observed on Banting Cres. The difference in the damage level on these two streets is dramatic, as can be seen in Fig. 1a. It was observed that most of the debris was confined to the backyards between these two streets. The centre of the tornado track appeared to be between these two streets, but likely closer to Stonemount Cres.

The width of the most significant damage was estimated to be about 25–30 m, while the overall width of the threshold of damage in this area was about 200 m. Surrounding the surveyed area, tree damage was found both to the west and to the east of the highly damaged area, and tended to be in line with the damage through the backyards. The part of the tornado path that exhibited DOD-6 damage to houses in Angus (i.e., which is nominally EF-2) extended for about 300 m. Examining the damage patterns and movement of debris, it appeared as though the tornado core was quite narrow since the damage was mostly contained within the backyards. In fact, the debris from Banting Cres. houses did not appear anywhere on this street; rather, the sheathing and shingles went in a northerly direction (towards Stonemount Cres.), and almost certainly in a north-easterly direction. This is likely the source of debris that broke the windows on the south-side (backyards) of the Stonemount Cres. houses, discussed below. However, the fences and other debris originating in the backyards could also be the source of debris for these broken windows. We also note that there was some debris (not much, but some) on the north-side of properties on Stonemount Cres. This is consistent with a vortex translation speed that must have been relatively high compared to its rotational speed because of the convergent debris pattern, as suggested by Bunting and Smith’s (1993) model for fast-moving tornadoes (see their fig. 4). Using the translation speed of the parent mesocyclone as a proxy leads to an estimated tornado translation speed of about 65 km/h (18 m/s). This,

**Fig. 1.** (a) Aerial photograph of the primary damage (source: Ian McInroy/Barrie Examiner, used with permission), and (b) a summary of all damage observations in Angus, ON, from survey of 18 June 2014 using an image from Google Earth. Red symbols indicate global roof failure, green symbols indicate roof sheathing failures (while the roof structure remained in place), and yellow symbols indicate all other damage. Note that construction was still occurring in this neighbourhood, so not all houses appear in the damage map. [Colour online.]

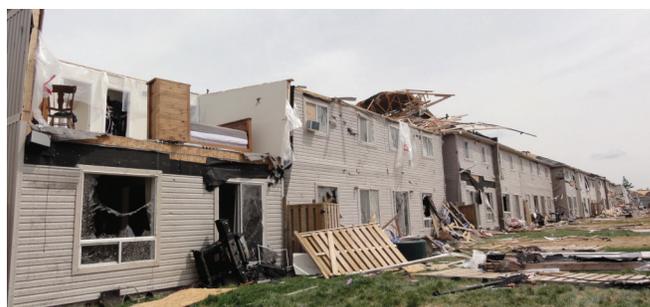
**Fig. 2.** House with observed roof and wall failure (source: the authors). [Colour online.]

demned and demolished. Most of these also lose the majority of their contents due to rain and wind damage. Ten of the eleven houses with complete roof failure had the roof becoming detached and blowing off of the walls. On the other house, the roof was displaced, but did not blow off. The blown-off roofs travelled in an east-southeasterly direction, along with other debris, and, in some cases, impacted adjacent houses. In all of the houses that had complete roof failure, there was at least one broken window on a single wall (on their south-side in the backyard), which appears to have played a significant role in these failures, as discussed below.

As seen in Figs. 1 and 2, many of the houses that lost their roofs were adjacent to each other indicating that the wind speeds were consistently above the threshold for this failure at this location. In addition, the authors examined the connections for all of the failed roof trusses that could be identified on the ground (and from high-resolution photographs of those remaining on the roof that could be seen from the street or backyard) and it was found that practically all of the toe-nailed roof-to-wall connections (RTWC) were below code requirements, with cases of zero, one, and two nails in the connections, rather than the code-required three. However, only a relatively small number of RTWC could be definitively identified, so any conclusions based solely on this evidence is tentative. (There is additional evidence of poor construction quality associated with wall failures, which is discussed further below.) Figure 3 shows an example of one roof truss, with evidence of only a single nail being used in the connection. Thus, improperly toe-nailed RTWC undoubtedly played a role in (at least some of) the roof failures.

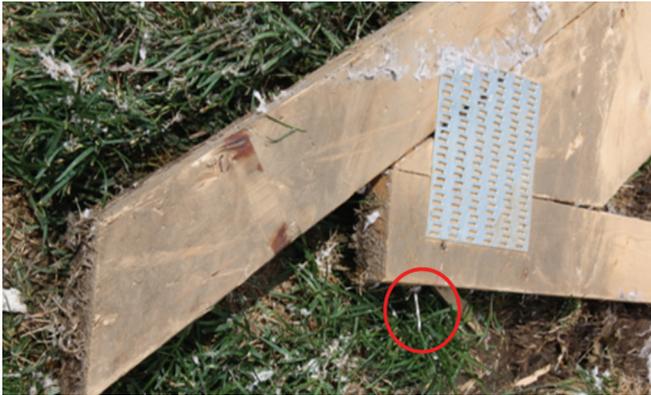
**Fig. 3.** Roof truss from a house with a structural roof failure. This roof truss had only one toe-nail in the connection, rather than the code-required three (source: the authors). [Colour online.]

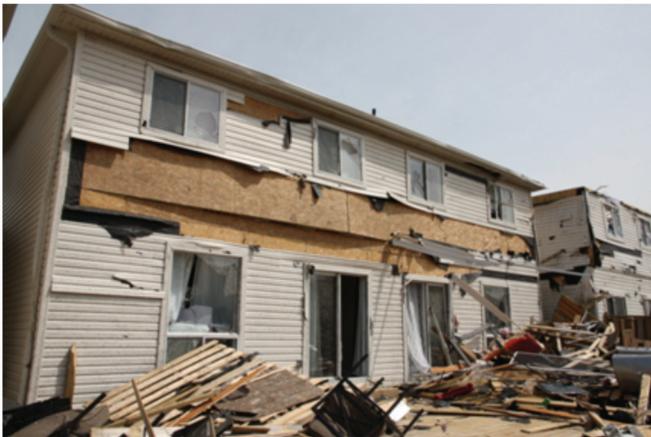
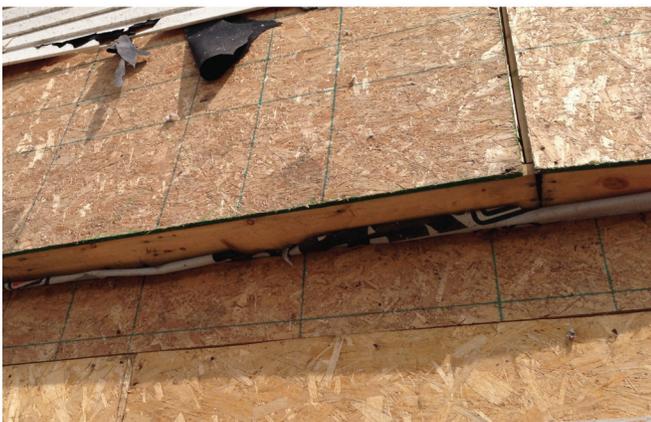
Further evidence for issues with quality of construction is provided in Fig. 4, which shows one of the structural wall failures. In this case, the second-floor wall was not fastened to the floor and it is likely that the pressure caused by wind sucked the unfastened wall outwards. A similar issue was found for the wall failure in Fig. 2, although the number of fasteners could not be identified.

**Fig. 4.** Wall failure due to missing inter-storey connections (source: the authors). [Colour online.]

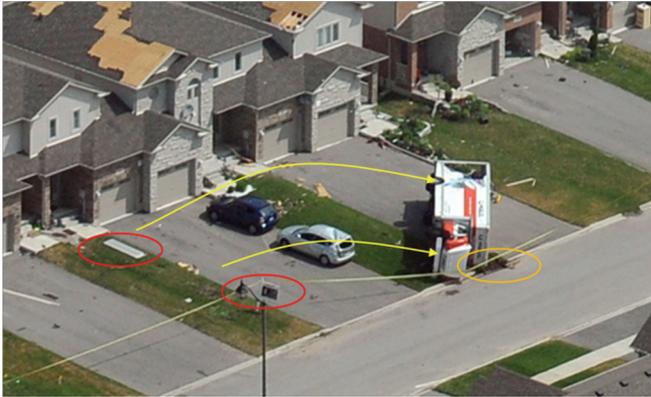
One of the interesting failures in Angus was a U-Haul box truck that was overturned by the wind. In fact, the evidence suggests that the truck was lofted, clipping one car as it went over two parked cars in the adjacent driveway, as illustrated in Fig. 5. The truck’s ramp remained on the front lawn suggesting that the vehicle had been parked there. Like for the flight of the roofs, the direction of the truck motion was in an east-southeasterly direction. No evidence of sliding was observed. Limited experimental evidence suggests that lofting a vehicle requires higher wind speeds than sliding or overturning (Haan et al. 2011). No other vehicles were observed to have moved in the storm, although homeowners were not contacted about this.

**Fig. 5.** Lofted and overturned U-Haul box truck with its likely direction of motion through the air indicated by the yellow arrows. The red circles indicate the ramp and for-sale sign while the orange circle indicates the location of greatest impact. Repetitive shingle, roof sheathing and garage door failures can also be seen in the photograph (source: Ian McInroy/Barrie Examiner, used with permission). [Colour online.]

Vehicle damage is not accounted for in the EF-Scale. In contrast, Fujita (1971) noted that vehicles can be lofted at F2, with 3 s gust wind speeds rated as 190–260 km/h (Table 2). Schmidlin et al. (2002) assessed that “semi-trucks and other high profile trucks, trailers, and buses may be tipped over” at F1 wind speeds, i.e., 125–190 km/h. Thus, the current results are consistent with those of Schmidlin et al. (2002), for the box truck both with and without a load. For lofting, the wind speeds would almost certainly be higher than the 150 km/h observed overturning of the empty truck. Since the EF-Scale in Canada has a range of 180–220 km/h for EF-2, it would appear that lofting of an empty box truck would occur in the upper EF-1 and perhaps into the EF-2 range of wind speeds given Haan et al.’s (2011) findings. Further work on lofting vehicles using tornado-vortex simulators will be needed to resolve the uncertainty with respect to this issue, particularly because of the vertical component of the wind, which may have been augmented at the location of the truck by the presence of the house. In the next section we address the correlation between this failure and those observed on the adjacent houses.

As noted above, overturning of an empty box truck likely occurs in the range of speeds from about 130 to 150 km/h. Higher speeds are expected for lofting of a box truck, which was observed in the Angus event. Adjacent to the truck failure are several houses with DOD-4 damage including roof sheathing failures and the inward collapse of garage doors. Figures 10 and 11 indicate that the wind speed for the median probability of failure for sheathing fastened with 8d nails is about 230 km/h for gable roofs and 260 km/h for hip roofs, assuming that there are no missing nails. These speeds appear to be considerably higher than the range of wind speeds for the box truck failure, and suggesting that the ‘expected’ value of 155 km/h for DOD-4 may be low for sheathing for panels with no errors, noting that no assessment could be made of missing nails in the damage survey. Further research on this seems warranted, in particular the effect of the vertical components of the wind on sheathing performance.

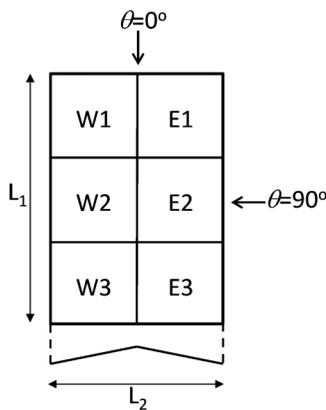
**Fig. 6.** Tributary area definitions used for fragility analysis of roof-to-wall connection failures.

nadoes, roof failures were encompassed by the wind directions in the range provided in Fig. 6 (0 degrees, or easterly-winds for this tornado, through to 90 degrees, or northerly). Based on the RTWC failures observed in Angus, three combinations of the effective tributary area,  $L_1 + R_1$ ,  $L_1 + L_2 + L_3$ ,  $R_1 + R_2 + R_3$  are considered.

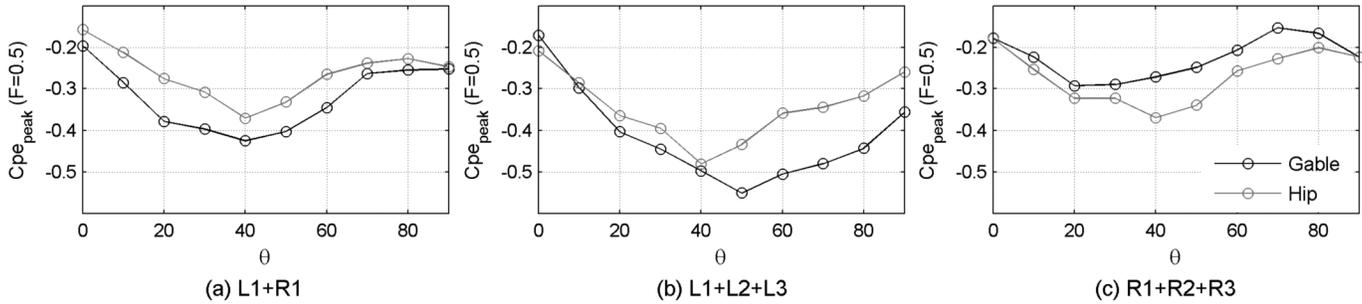
Fig. 7.  $C_{pe}$  variation for G6/12 and H6/12, neigh 1, suburban, 2-story house for RTWC failure.

where  $x$  is either  $C_{p_{eA}}$  or  $C_{p_{iA}}$ ,  $\alpha$  and  $u$  are the scale and location parameters that can be determined by the least-squares method. Figure 7 shows the peak coefficients that correspond to the 50th percentile (i.e., median) for the effective tributary areas of  $A_E = L1 + R1, L1 + L2 + L3,$  and  $R1 + R2 + R3$ .

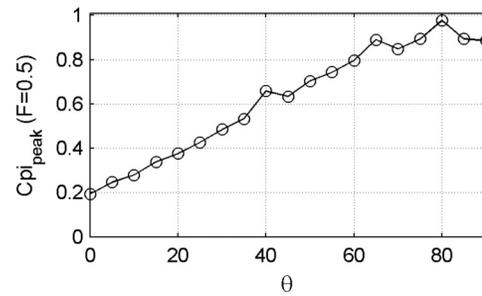
Fig. 8.  $C_{pi}$  variation for Angus house configuration for both RTWC and sheathing panel failure (6/12, suburban, 2-story house).

The building internal pressure,  $C_{pi}$ , was based on an assumed dominant opening of a size of  $1.2 \text{ m} \times 1.2 \text{ m}$ , typical of windows for the houses in Angus. This opening was assumed to be located near the centre of the side wall, consistent with the damage observations, which leads to the variation of  $C_{pi}$  versus wind direction depicted in Fig. 8. (The area of the overhangs was included with the internal pressures, which were assumed to act on the ceiling between the living space and the attic and also on the overhangs.) The internal pressure coefficients were obtained by considering the wall-pressure time series from one of the tested models in the National Institute of Standards and Technology (NIST) aerodynamics database — see Ho et al. (2005) — with  $L \times W \times h_{\text{eave}} = 19.1 \text{ m} \times 12.2 \text{ m} \times 5.5 \text{ m}$ .

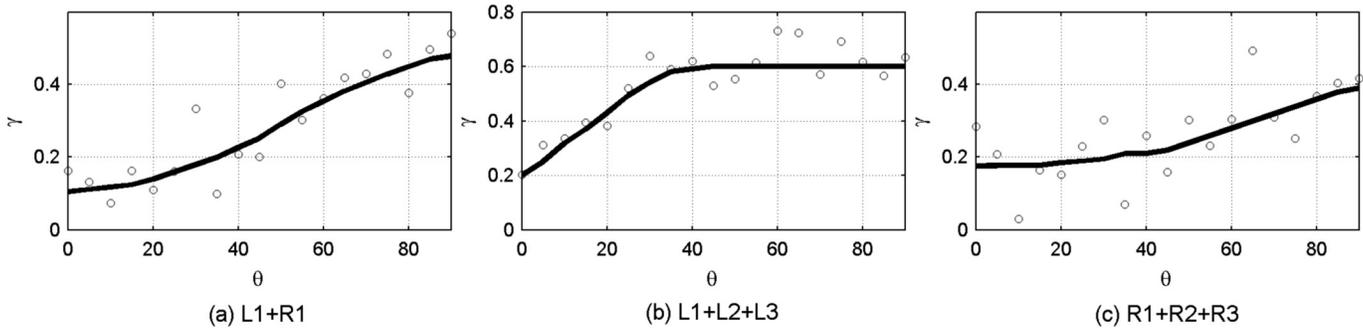
**Fig. 9.** Variation of  $\gamma$  with respect to wind direction,  $\theta$ . The solid black line is a smoothed curve fit, which is used in the current analysis.

Since the peak external and internal pressures were not measured simultaneously, the correlation between the peaks,  $\gamma$ , must be assessed to obtain the peak, net wind loads. To obtain  $\gamma$  for RTWC failure, wind tunnel data measured on the roof and walls simultaneously were utilized for this purpose, using the same data as were used to assess the internal pressure coefficients. The area-averaged  $C_{p_e}$  time series for the effective roof areas were cut into 10 equal segments and the minima were obtained from each segment. With  $C_{p_{iA}}$  time series obtained on the side wall as explained above,  $C_{p_{iA}}$  values corresponding to these 10  $C_{p_{eA}}$  minima were selected and the mean value was calculated. This is denoted as  $C_{p_{iAmean}}$ . At the same time, the worst single peak was also found from  $C_{p_{iA}}$  time series, which is denoted as  $C_{p_{iApeak}}$ . Then,  $\gamma$  was obtained from the ratio,  $C_{p_{iAmean}}/C_{p_{iApeak}}$ . This was repeated for all wind directions and roof zones. The  $\gamma$  variations with wind direction for  $L1 + R1, L1 + L2 + L3,$  and  $R1 + R2 + R3$  are presented in Fig. 9. For sheathing panel failure analysis in particular, simultaneous external and internal pressure coefficients would be useful, but are unavailable for buildings of this size, with these roof shapes. Since only the first sheathing panel failure is considered in this analysis, a constant value of  $\gamma = 0.85$  regardless the location of panel and wind direction was used, based on the results from Kopp et al. (2008). This approach is consistent with existing, code-based fragility analyses of sheathing failures.

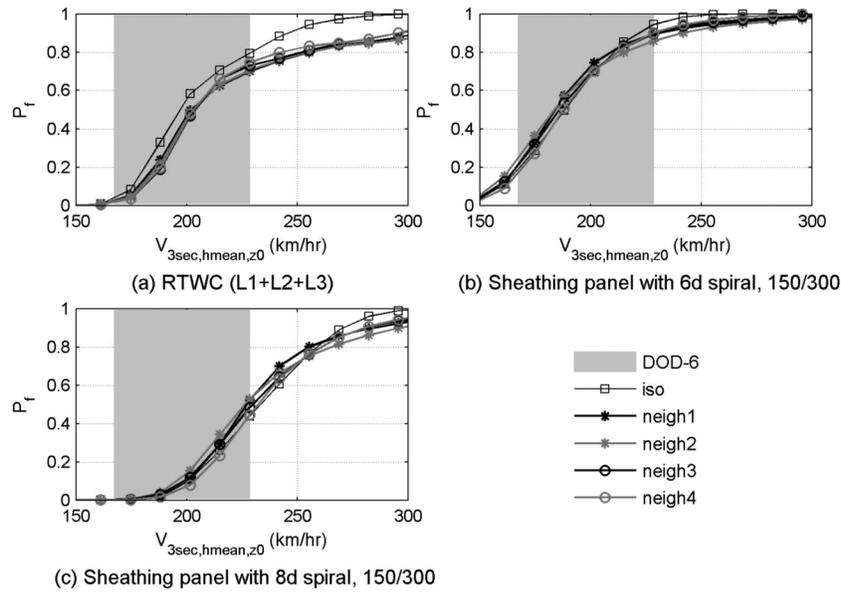
Figures 10 and 11 depict the resulting fragility curves for isolated, 2-storey houses in a suburban terrain with gable and hip roofs, respectively, with roof slopes of 6/12 and a dominant opening in the side wall. The roof slope of 6/12 was selected based on the houses observed in the damage survey in Angus. In addition, the gray range indicated in the figures is DOD-6 wind speed range. From these figures, it is clear that the roof shape has a significant effect on the failure-inducing wind speeds. For RTWC failure, the increase in the median failure wind speeds for the hip-roof compared to the gable-roof is about 50 km/h for the same effective wind area, with the gable-roof failures falling in the range of wind speeds associated with DOD-6, while the hip-roof failures tend to fall outside (above) this range, except for very low probabilities of failure. It should be emphasized that EF-Scale categories as implemented in Canada span ranges of 40 km/h, so a difference of 50 km/h is greater than one category in the EF-Scale.

When the fragility curves for the RTWC and sheathing panel failures of gable roofs are compared, the curves for RTWC failure locate between the two curves for 6d-nail and 8d-nail sheathing panel failures, regardless of the neighbourhood configuration (except at high values of failure probability). Thus, if 6d nails are used for the sheathing, one would expect to see greater numbers of sheathing failures than RTWC failures (or, perhaps, RTWC failures with panels missing from the roof). However, if 8d nails are used for the sheathing, complete (gable) roof failure is more likely.

**Fig. 10.** Fragility curves in different neighbourhood patterns for gable-roofed 2-story houses with a roof slope of 6/12 and a dominant opening on the side wall in suburban terrain.

Considering the current fragility analysis, the median value for gable roofs with code-based, toe-nailed RTWCs is about 200 km/h (Fig. 10). For hip roofs it is about 260 km/h (Fig. 11). Thus, the current analysis indicates that the EF-Scale is appropriate for gable roofs, but underestimates the failure-inducing wind speeds for global failure of hip roofs even with Environment Canada’s (2013) added note to use the upper end of the range (i.e., 230 km/h) for hip roofs. Interestingly, Fujita’s original scale appears to give closer values. While wind tunnel tests in tornado-like vortex flows would be desirable to confirm such results, particularly to account for the vertical component of the wind, it appears likely that the EF-Scale DIs should distinguish between these roof shapes for wood-frame houses.

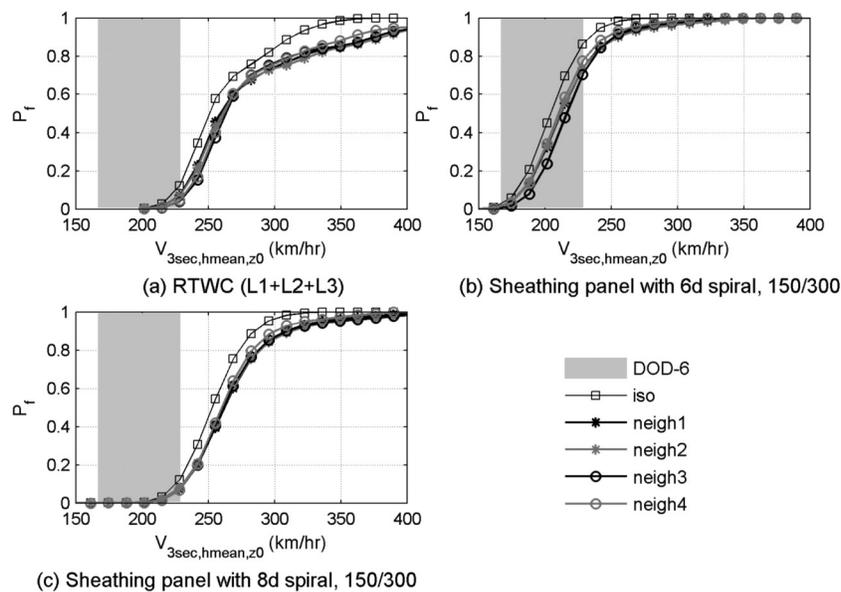
**Fig. 11.** Fragility curves in different neighbourhood patterns for hip-roofed 2-story houses with a roof slope of 6/12 and a dominant opening on the side wall in suburban terrain.

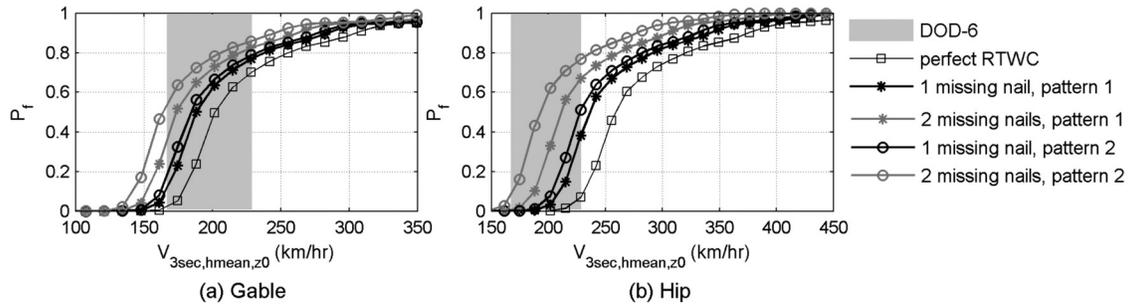
RTWC using 3 toe nails will be denoted as ‘perfect RTWC’. Based on Morrison and Kopp (2011) we have assumed two possible patterns for the reduction in capacity due to missing nails. One is to reduce the  $R_{0mean}$  by 25% and 50% for 2-nails and 1 nail per connection, respectively (denoted as ‘pattern 1’). The other is to reduce the  $R_{0mean}$  by 1/3 (33%) and 2/3 (66%) for 2-nails and 1 nail per connection, respectively (denoted as ‘pattern 2’). For both patterns, the standard deviation of  $R$ ,  $R_{0SD}$  was reduced by 20% from the perfect RTWC regardless the number of missing nails. With this information, the fragility analyses were repeated using one of the neighbourhood cases (‘neigh1’), one of the combined wind effective zones (L1 + L2 + L3), and the results for gable and hip roofs with slopes of 6/12. The results are presented in Fig. 12.

The results show that missing fasteners will reduce the failure-inducing wind speeds substantially. For the gable roofs, the wind

**Fig. 12.** Effect of missing nails on effective wind zone of L1 + L2 + L3 of (a) gable- and (b) hip-roofed 2-story houses with a roof slope of 6/12 and a dominant opening on the side wall, surrounding by neighbouring models in suburban terrain.

speed at the median failure probability (i.e.,  $P_f = 0.5$ ) is reduced from about 200 km/h for “perfect” connections to about 160–170 km/h when two nails are missing from every connection. For hip roofs, the change is more substantial, going from about 250 km/h at  $P_f = 0.5$  to 180–200 km/h. For these types of errors, the gable roof wind speeds at  $P_f = 0.5$  are on the lower side of the DOD-6 range (even falling below the minimum value) while those for the hip roofs (at  $P_f = 0.5$ ) are in the middle of the DOD-6 range.

As discussed in the introduction, the EF-Scale (WSEC 2006) report discusses the effects of missing fasteners, such that the effects of missing fasteners imply that the lower bound for DOD-6 should be used, i.e., 165 km/h. The current results suggest that the lower bound of 165 km/h for DOD-6 is reasonable for a typical or average failure wind speed, with median values of about 160–170 km/h found for the case of two missing nails on gable roofs (Fig. 12), while being higher for hip roofs (180–200 km/h; Fig. 12). Thus, the lower bound speed for DOD-6 appears to be sufficiently accurate to deal with errors for gable roofs, while the expected value for the current DOD-6 applies to hip roofs with significant errors in the toe-nailed connections.

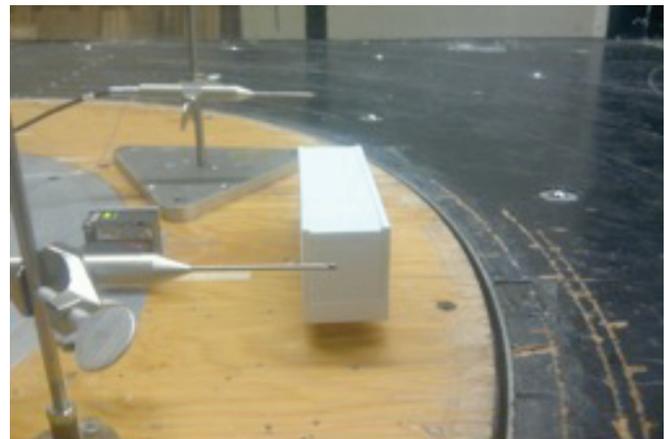
Our interest here is to assess blow-over speeds for a box truck using the failure-model approach (Surry et al. 2005; Visscher and Kopp 2007). A model of the truck was constructed with rapid prototyping methods using a length scale,  $\lambda_L = L_m/L_p = 1/50$  where  $L$  is a length, the subscript, m, represents model scale, and the subscript, p, represents the prototype (i.e., full scale). The nominal size of the truck at this scale is 196 mm by 49 mm in plan and 74 mm in height. A photograph of the model is provided in Fig. 13. The mass scale ( $\lambda_m = M_m/M_p$ , where  $M$  is mass) can be calculated as  $\lambda_m = \lambda_\rho \lambda_L^3$ . Here, the density scale,  $\lambda_\rho = \rho_m/\rho_p = 1$ . The full-scale mass of the box truck used for the tests was assumed to be 8260 kg, which represents a fully-loaded condition. For  $\lambda_L = 1/50$  and  $\lambda_\rho = 1$ , this leads to a model-scale mass of 66 g. It should be noted that the truck appeared to be empty before being lofted. Thus, the analysis below will consider the empty weight, which is assumed to be 5670 kg, or 45 g in model scale, i.e., 69% of the test weight.

**Fig. 13.** Photograph of the box truck model in the wind tunnel showing the set-up for the Cobra probes and displacement transducer.

The current tests involved the overturning failure of a model truck placed on a plywood surface such that the model had the same friction coefficient as tires on asphalt. The wind tunnel speed was increased slowly until the vehicle slid or overturned, following the procedure developed by Visscher and Kopp (2007). Overturning failure was the primary mode of failure. In the simulated boundary layer flows, Cobra probe measurements were made simultaneously with a displacement transducer so that the gust speed at failure and an equivalent 3 s speed could be determined directly from the recorded data. Equivalent, 3 s gust wind speeds were obtained using the time scale relationships set by the use of the Froude scaling. Further details can be found in Stedman (2012). Twenty-five tests were conducted in each terrain configuration.

Using the Froude number scaling, the average instantaneous wind speeds at failure were 49 and 53 m/s for the two terrain conditions, with a standard deviation of about 5–6% for each. Using the time histories of wind speed measured from the Cobra probes, along with the Froude scaling, the equivalent 3 s gust speeds were found to be in the range 45–51 m/s (160–180 km/h). Assuming that the overturning moment coefficient does not change, the empty truck would have overturned at a wind speed that is 17% lower, yielding a range of 37–42 m/s (130–150 km/h). Lofting of the vehicle would be expected at higher speeds. For example, Haan et al. (2011) found in their tornado-vortex simulator study that lofting speeds for a minivan are 50% higher than overturning speeds in the same vortex.
