Land Use Evolution and Run Off at York University Keele Campus

**Laura Antoniazzi
Katia Canil
Ignazio Giuntoli
Julia Rodrigues Leite
Anne Sabourin**

Nov 27, 2006

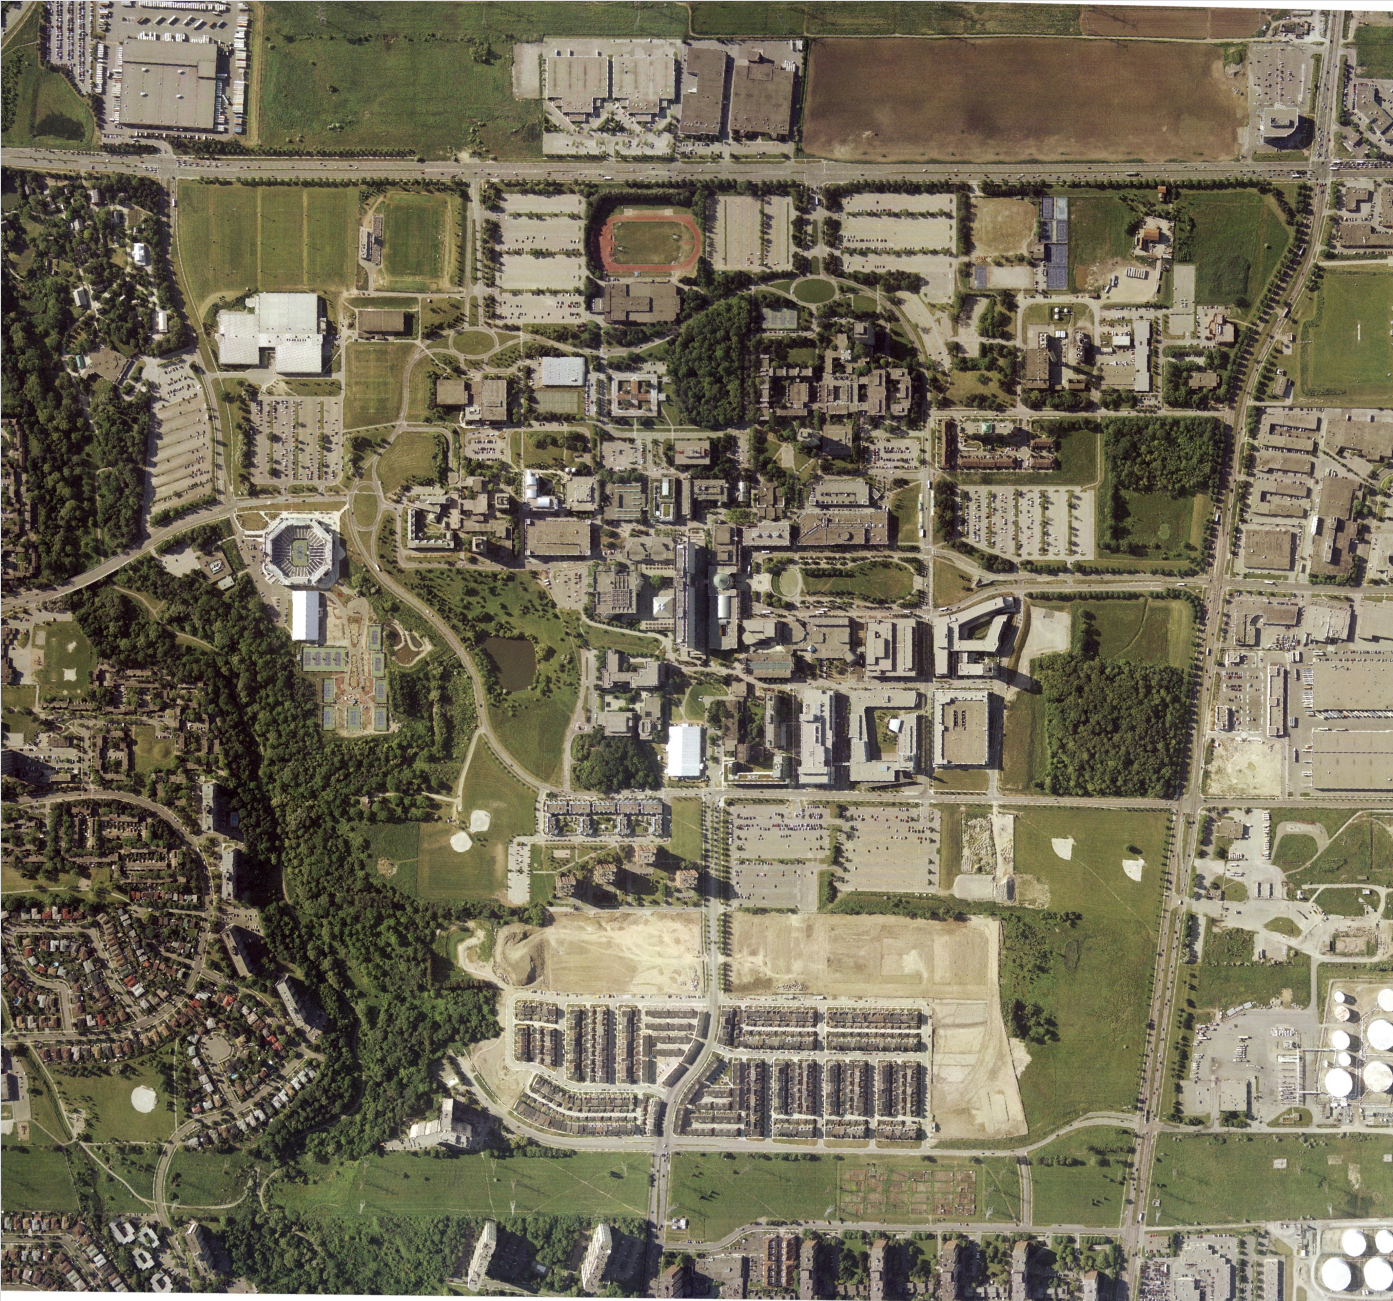
York Campus, 2006. Source: Facilities Services York University

York University is located in the Humber River Watershed and closely borders the Don River Watershed.

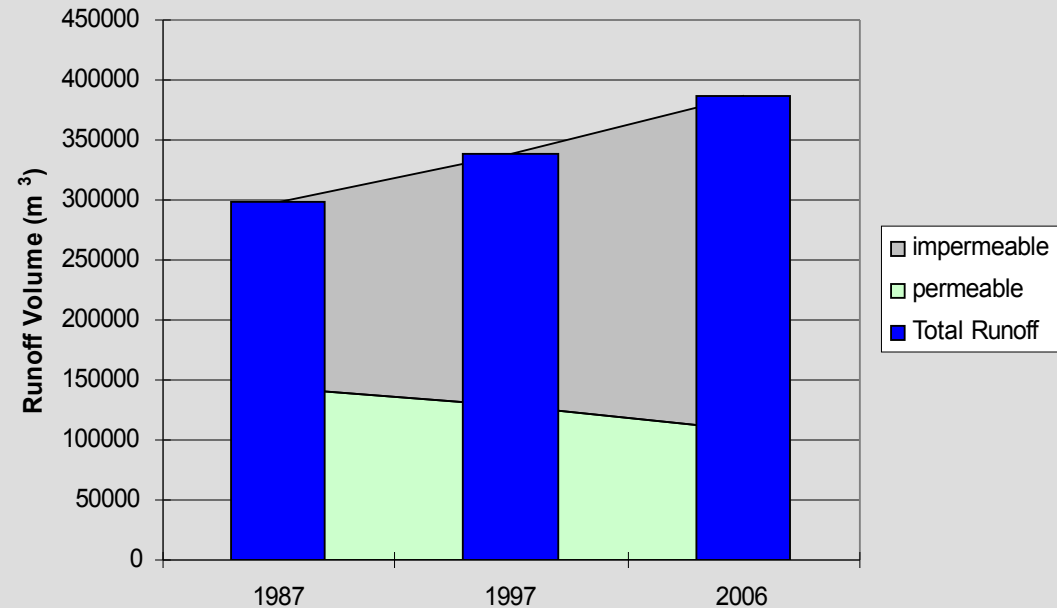
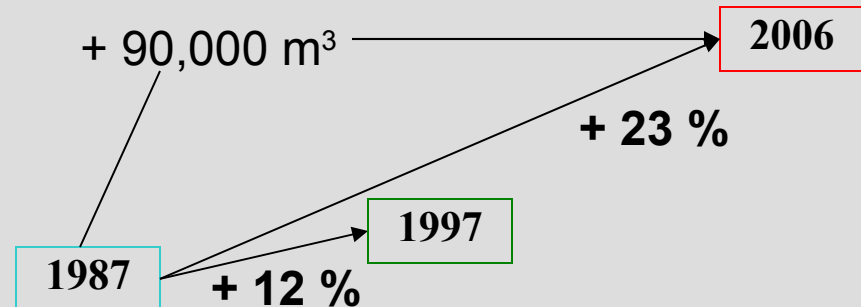
Annual Water Runoff Evolution

1987

Ann Runoff (Imp Area) = 155648 m³
Ann Runoff (Perm Area) = 142778 m³

Total Annual Runoff
298426 m³

1997

Ann Runoff (Imp Area) = 127696 m³
Ann Runoff (Perm Area) = 209944 m³

Total Annual Runoff
337640 m³

2007

Ann Runoff (Imp Area) = 108592 m³
Ann Runoff (Perm Area) = 278719 m³

Total Annual Runoff
387311 m³
