# York University Event Space Assessment

York University, 4700 Keele Street, North York, ON M3J  
1P3

Project Number: P3005744

Report Date: 1 September 2026

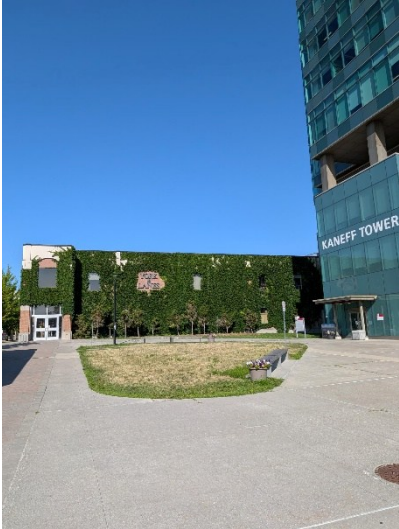
| Item | Description | Photos |
|---|---|---|
| 1 | Entrance to York Lanes Mall adjacent to Kaneff Tower. | A photograph showing the entrance to York Lanes Mall, a paved walkway leading to a building with a green wall. To the right is Kaneff Tower, a modern glass building with the name 'KANEFF TOWER' visible on its facade. The sky is clear blue. |

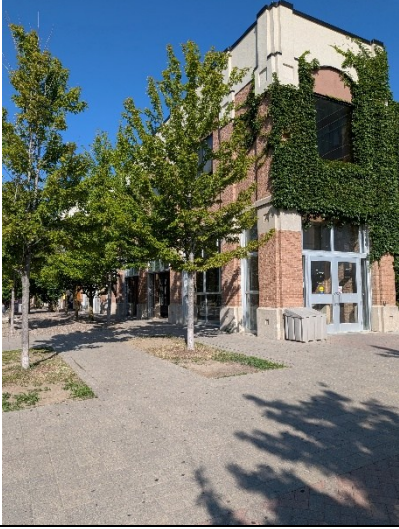
| Item | Description | Photos |
|---|---|---|
| 2 | Entrance to York Lanes promenade along York Boulevard. | A photograph showing the entrance to the York Lanes promenade, a paved walkway leading to a brick building with a green wall. The building is partially covered in ivy. The sky is clear blue. |

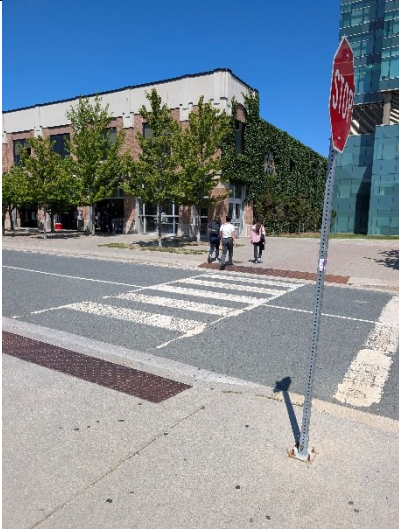
| Item | Description | Photos |
|---|---|---|
| 3 | Pedestrian crossing towards entrance to York Lanes promenade along York Boulevard. | |

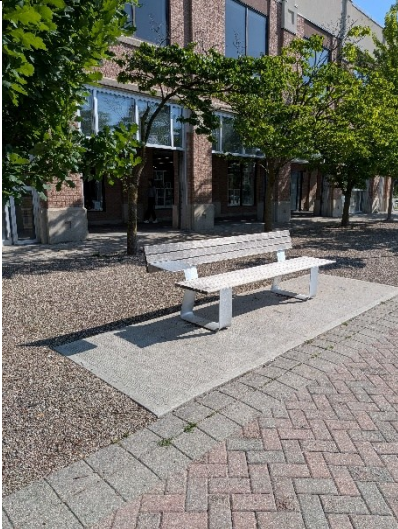
| Item | Description | Photos |
|---|---|---|
| 6 | Rest area with accessible bench seating that has arm and back support and clear ground space adjacent to open end. | |

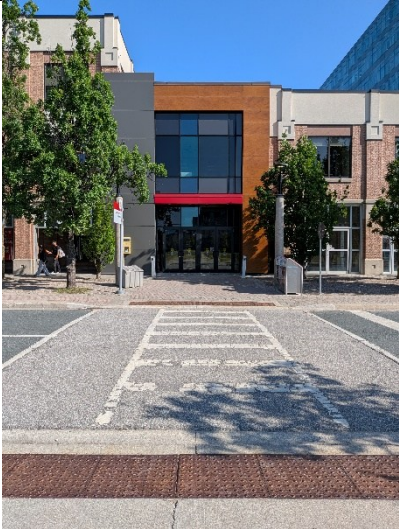
| Item | Description | Photos |
|---|---|---|
| 8 | Primary entrance to York Lanes (York University) and elevator lobby to event space. | |

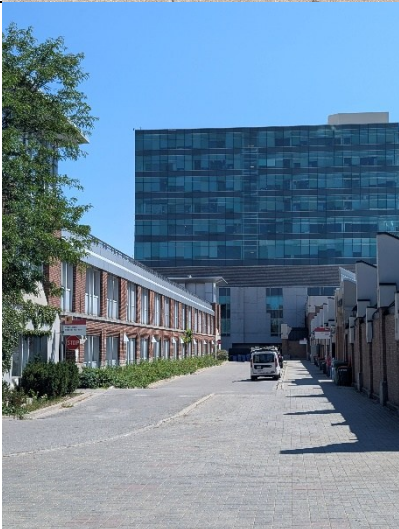
| Item | Description | Photos |
|---|---|---|
| 9 | Vanier Parking Garage and pick-up and drop-off area along Vanier Lane. | |

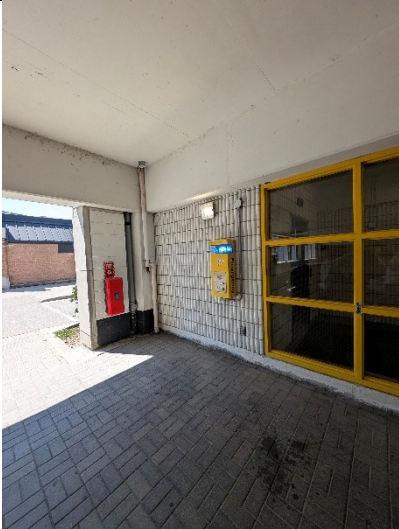
| Item | Description | Photos |
|---|---|---|
| 10 | Emergency blue light system within Vanier Parking Garage. | |

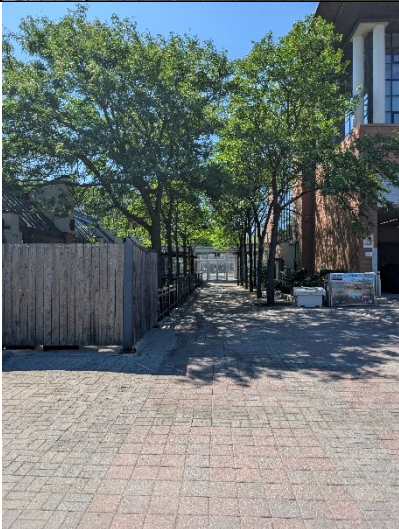
| Item | Description | Photos |
|---|---|---|
| 12 | Access to York Lanes promenade via Vanier Lane. | |

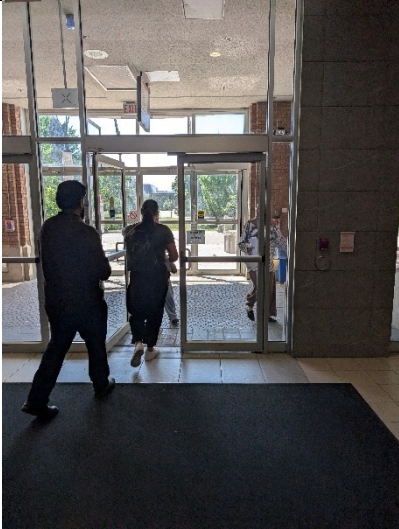
| Item | Description | Photos |
|---|---|---|
| 13 | Vestibule of primary entrance to York Lanes (York University) and elevator lobby to event space. | |

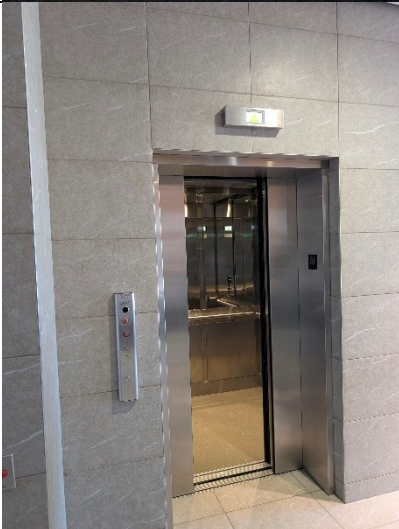
| Item | Description | Photos |
|---|---|---|
| 14 | Elevator to access second and third floor. | |

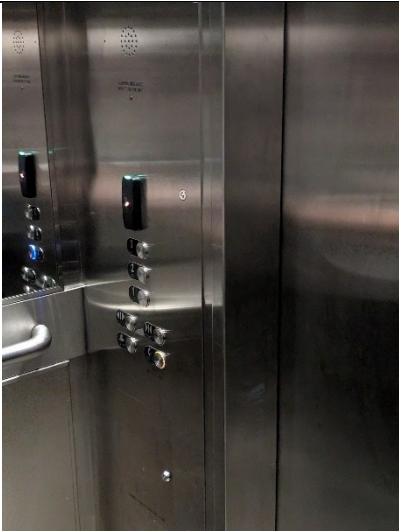
| Item | Description | Photos |
|---|---|---|
| 15 | Elevator controls. | |

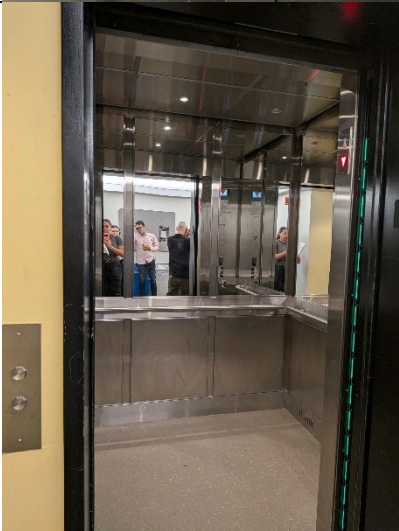
| Item | Description | Photos |
|---|---|---|
| 16 | Elevator cab. | |

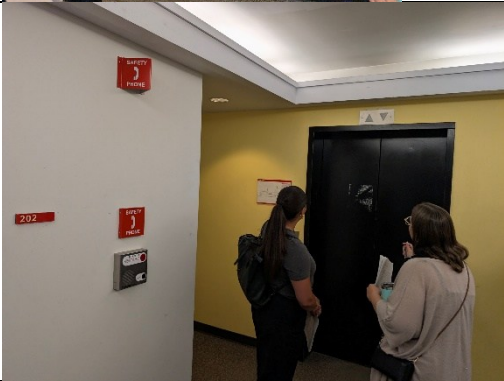
| Item | Description | Photos |
|---|---|---|
| 18 | Emergency phone at elevator lobby at second floor. | |

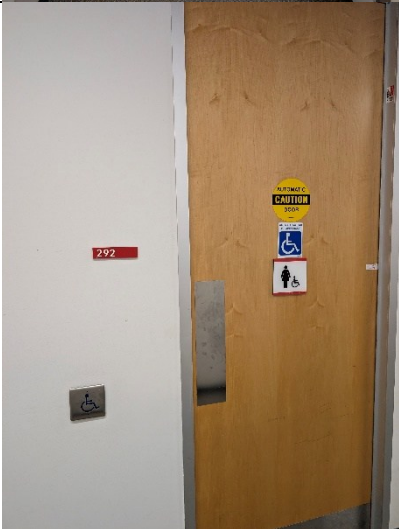
| Item | Description | Photos |
|---|---|---|
| 21 | Barrier-free women's washroom at second floor. | |

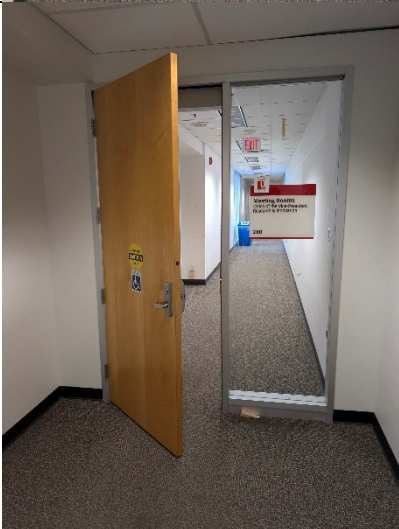
| Item | Description | Photos |
|---|---|---|
| 28 | Corridor towards boardroom 280N including automatic doors. | |

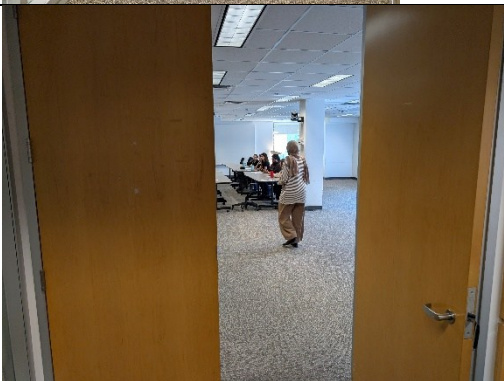
| Item | Description | Photos |
|---|---|---|
| 31 | Entry door into boardroom 280N. | |

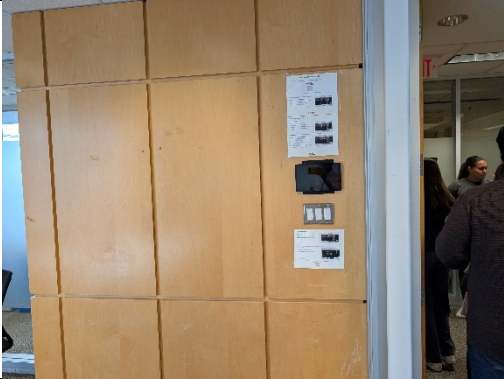
| Item | Description | Photos |
|---|---|---|
| 32 | Lighting controls within boardroom 280N. | |

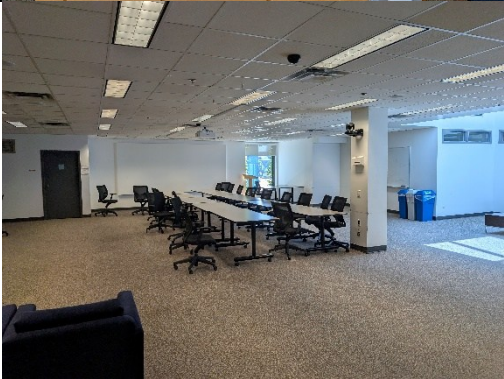
| Item | Description | Photos |
|---|---|---|
| 33 | Non-fixed furniture, fixtures, and equipment within boardroom 280N with flexible size and space for approach and use. | |

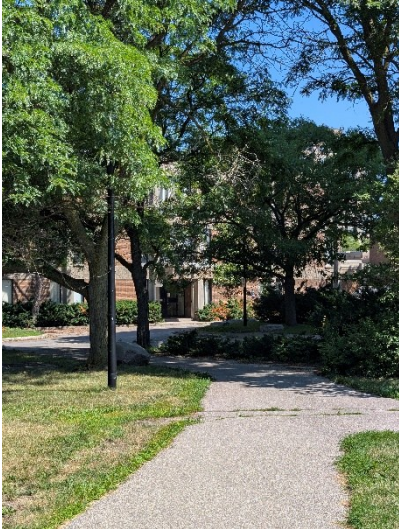
| Item | Description | Photos |
|---|---|---|
| 1 | Exterior path of travel towards stepped alternative entrance at Founders College. | |

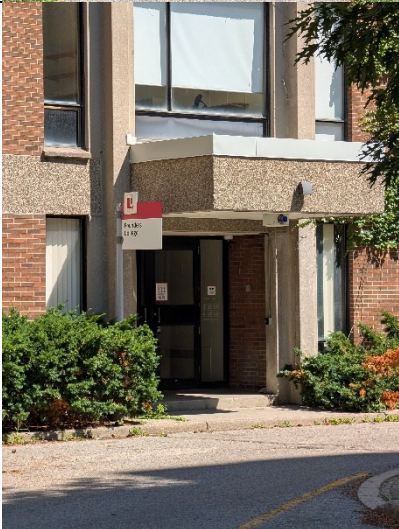
| Item | Description | Photos |
|---|---|---|
| 2 | Stepped alternative entrance at Founders College. | |

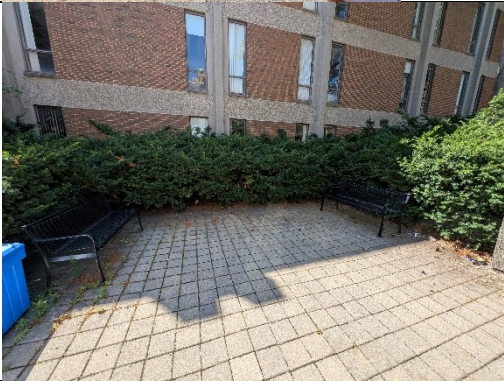
| Item | Description | Photos |
|---|---|---|
| 6 | Rest area with bench seating that has arm and back support and clear ground space. | A photograph of a rest area featuring two black metal benches with armrests and backrests. The benches are situated on a paved area with a brick building and greenery in the background. |

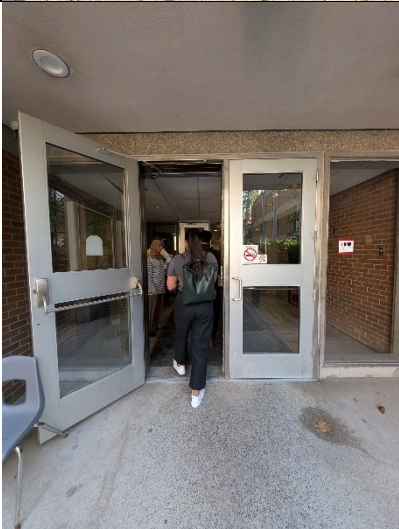
| Item | Description | Photos |
|---|---|---|
| 7 | Primary entrance at Founders College including vestibule with double automatic doors. | A photograph of the primary entrance to Founders College, showing a vestibule with double automatic glass doors. A person is walking through the entrance, and a brick wall is visible on the right side. |

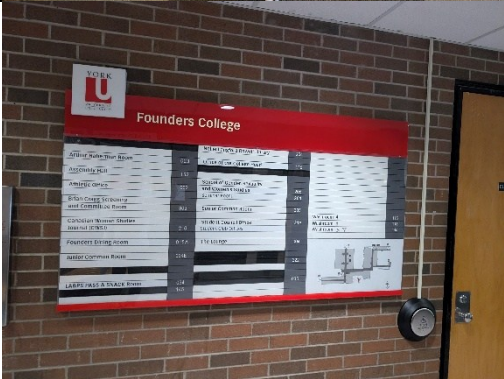
| Item | Description | Photos |
|---|---|---|
| 9 | Wall mounted floor directory signage. | |

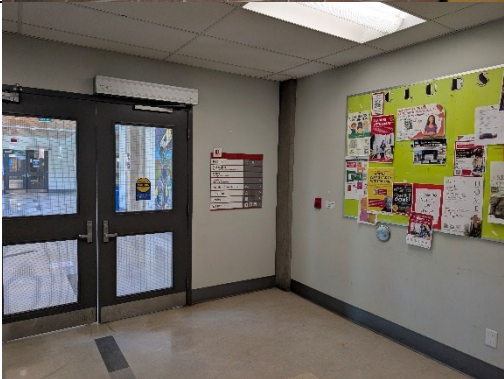
| Item | Description | Photos |
|---|---|---|
| 10 | Corridor towards Founders Assembly Hall Room 152 with automatic doors. | |

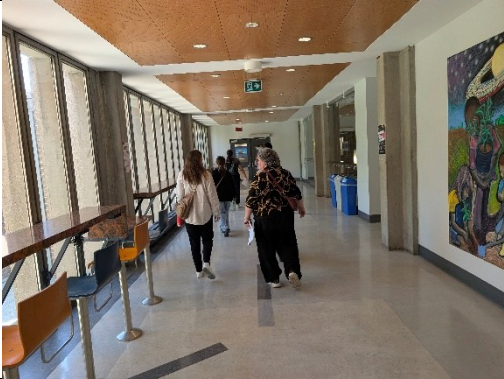
| Item | Description | Photos |
|---|---|---|
| 11 | Corridor towards Founders Assembly Hall Room 152 with tables and seats of various heights. | |

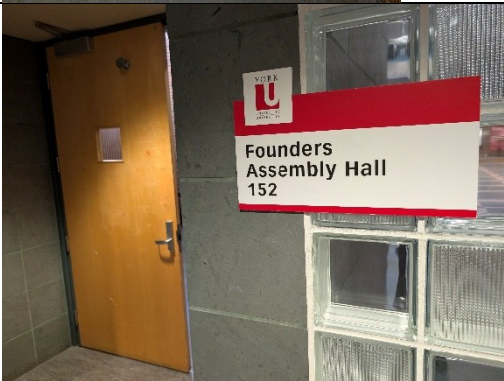
| Item | Description | Photos |
|---|---|---|
| 13 | Single entry door to Founders Assembly Hall Room 152. | |

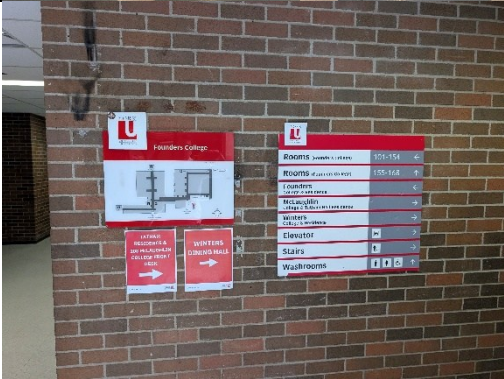
| Item | Description | Photos |
|---|---|---|
| 18 | Wall mounted directory signage within Founders College. | |

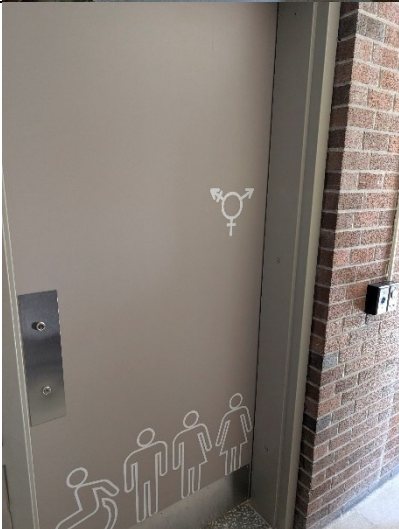
| Item | Description | Photos |
|---|---|---|
| 21 | All gender multi stall washroom. | |

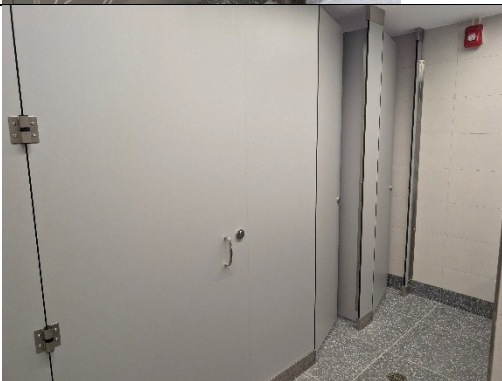
| Item | Description | Photos |
|---|---|---|
| 22 | Water closet stalls within all gender multi stall washroom. | |

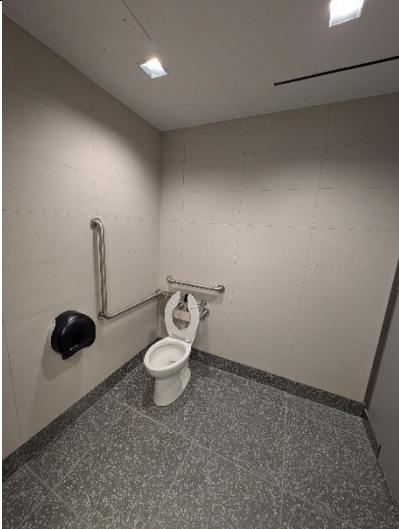
| Item | Description | Photos |
|---|---|---|
| 23 | Barrier-free water closet stall within all gender multi stall washroom. | |

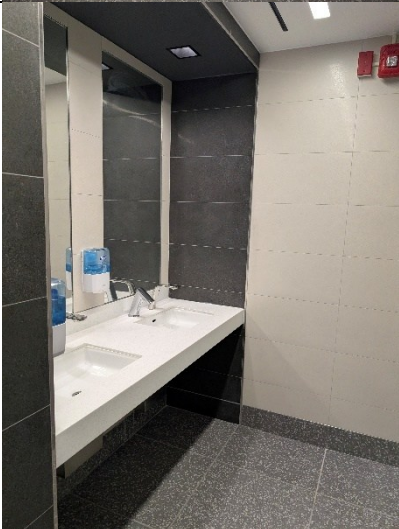
| Item | Description | Photos |
|---|---|---|
| 24 | Barrier-free lavatory within all gender multi stall washroom. | |

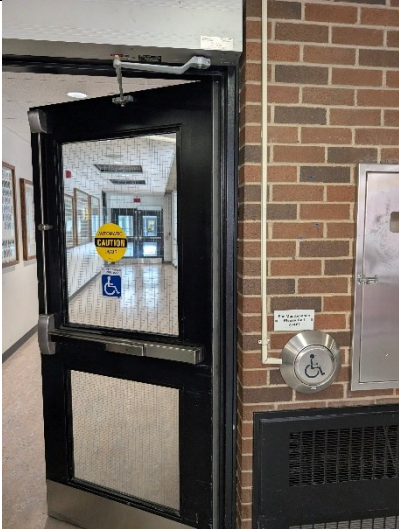
| Item | Description | Photos |
|---|---|---|
| 3 | Corridor towards Senior Common Room 140 with automatic doors. | |

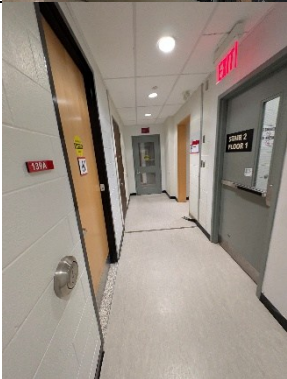
| Item | Description | Photos |
|---|---|---|
| 4 | Corridor toward single occupancy barrier-free washroom towards Senior Common Room 140. | |

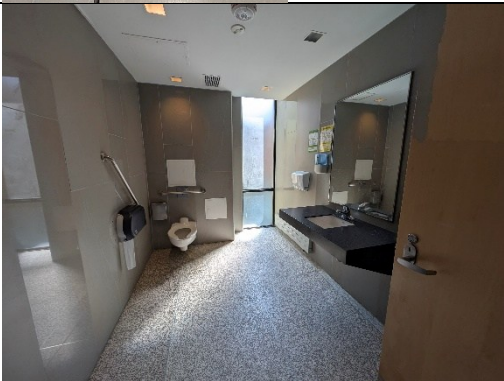
| Item | Description | Photos |
|---|---|---|
| 5 | Single occupancy barrier-free washroom. | |

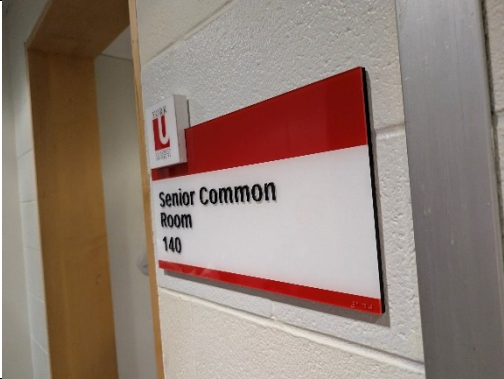
| Item | Description | Photos |
|---|---|---|
| 6 | Door identification signage with braille at Senior Common Room 140. | |

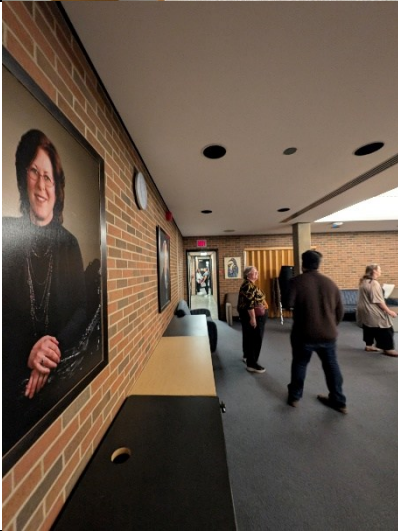
| Item | Description | Photos |
|---|---|---|
| 7 | Non-fixed furniture, fixtures, and equipment within Senior Common Room 140 with flexible size and space for approach and use. | |

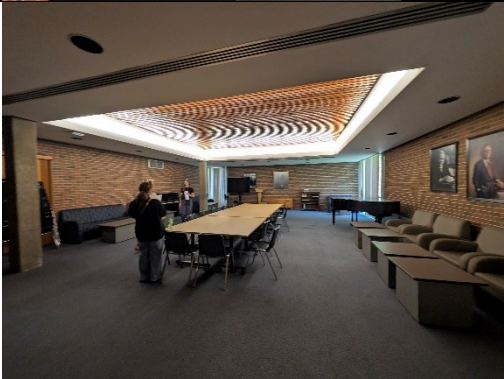
| Item | Description | Photos |
|---|---|---|
| 8 | Non-fixed furniture, fixtures, and equipment including lounge seating within Senior Common Room 140 with flexible size and space for approach and use. | |

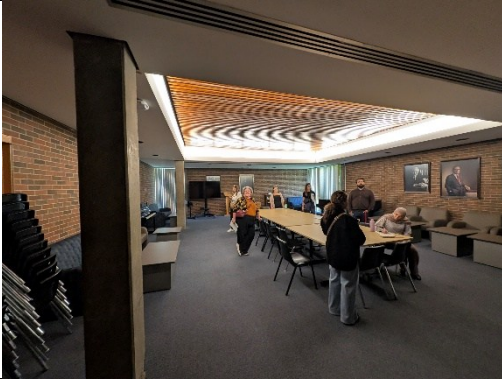
| Item | Description | Photos |
|---|---|---|
| 9 | Non-fixed furniture, fixtures, and equipment within Senior Common Room 140 with flexible size and space for approach and use. | |

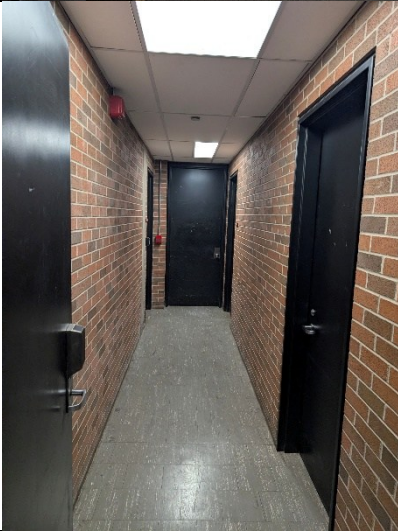
| Item | Description | Photos |
|---|---|---|
| 10 | Alternative entry into Senior Common Room 140. | |

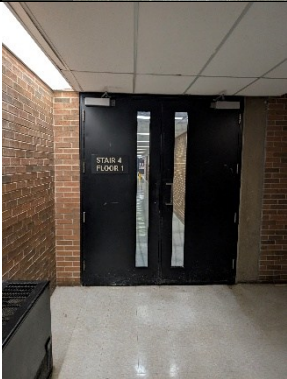
| Item | Description | Photos |
|---|---|---|
| 11 | Alternative entry into Senior Common Room 140 with connection to corridor towards stair 4. | |

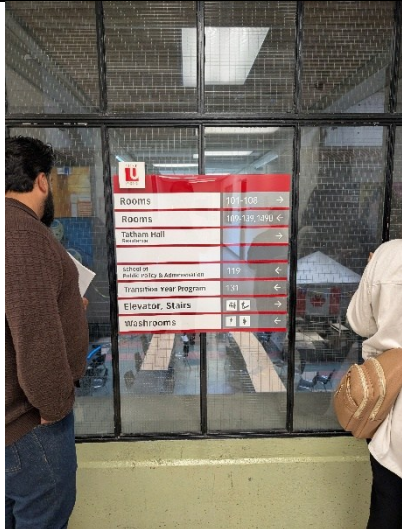
| Item | Description | Photos |
|---|---|---|
| 1 | Wall mounted floor directory signage. | |

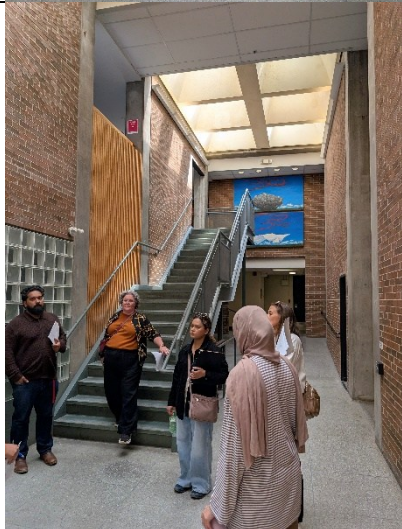
| Item | Description | Photos |
|---|---|---|
| 3 | Stair connecting the first and basement level towards Renaissance Junior Common Room 001. | |

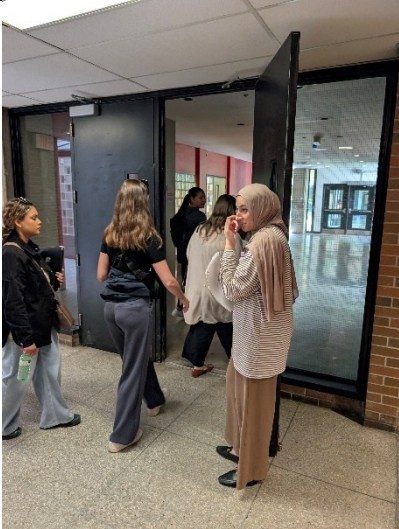
| Item | Description | Photos |
|---|---|---|
| 4 | Corridor and double door towards Renaissance Junior Common Room 001. | |

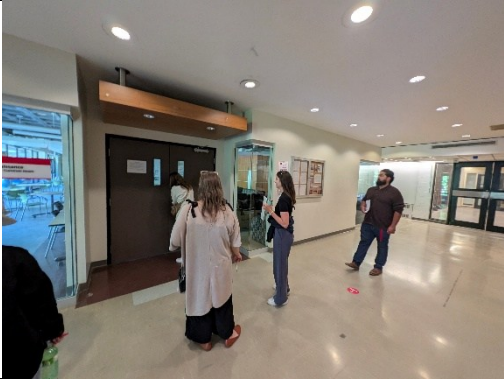
| Item | Description | Photos |
|---|---|---|
| 7 | Entry door into Renaissance Junior Common Room 001. | |

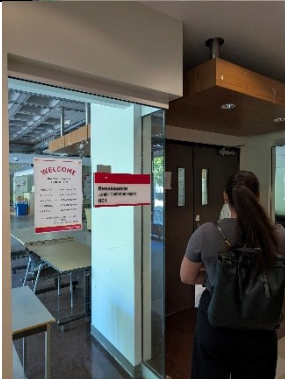
| Item | Description | Photos |
|---|---|---|
| 8 | Door identification signage with braille mounted on glazing for Renaissance Junior Common Room 001. | |

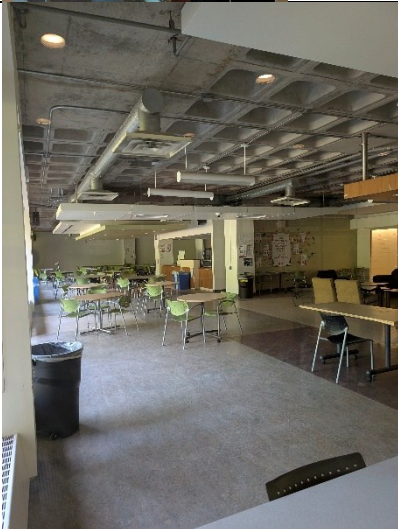
| Item | Description | Photos |
|---|---|---|
| 9 | Non-fixed furniture, fixtures, and equipment within Renaissance Junior Common Room 001 with flexible size and space for approach and use. | |

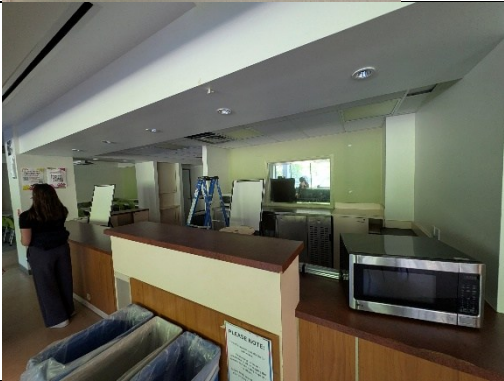
| Item | Description | Photos |
|---|---|---|
| 14 | Food services counter showing a variety of counter heights. | |

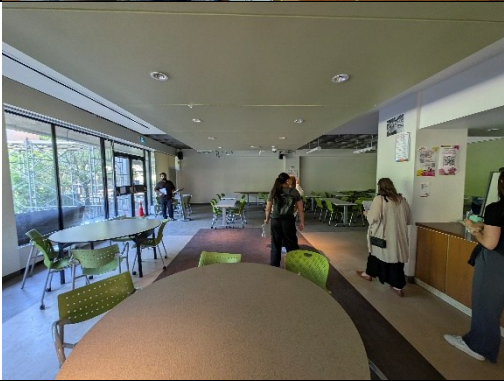
| Item | Description | Photos |
|---|---|---|
| 15 | Non-fixed furniture, fixtures, and equipment within Renaissance Junior Common Room 001 with flexible size and space for approach and use. | |

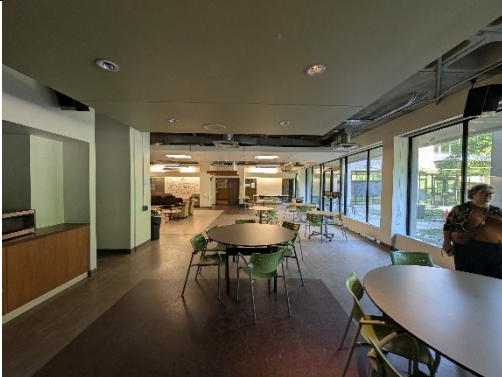
| Item | Description | Photos |
|---|---|---|
| 16 | Non-fixed furniture, fixtures, and equipment within Renaissance Junior Common Room 001 with flexible size and space for approach and use. | |

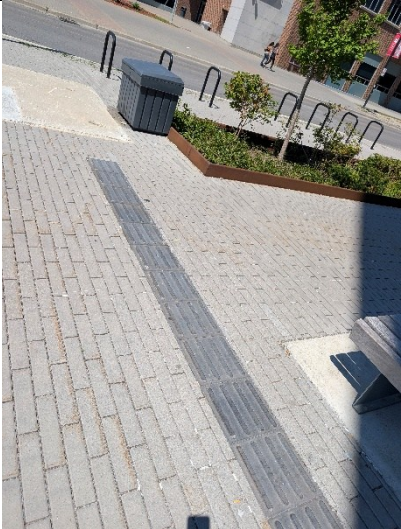
| Item | Description | Photos |
|---|---|---|
| 2 | Tactile direction indicators leading to primary entrance to School of Continuing Studies. | |

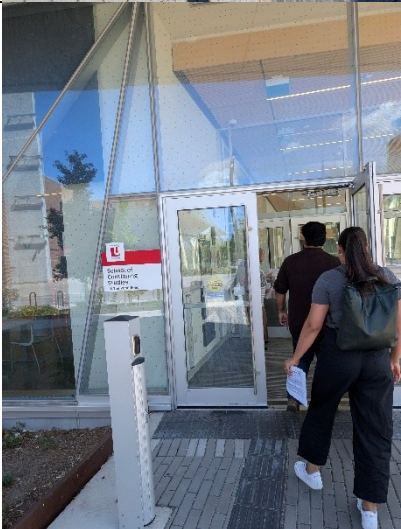
| Item | Description | Photos |
|---|---|---|
| 3 | Primary entrance including vestibule with double automatic doors. | |

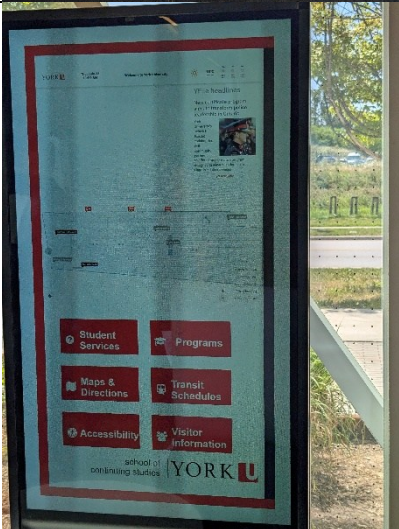
| Item | Description | Photos |
|---|---|---|
| 7 | Digital directory available within lobby. | |

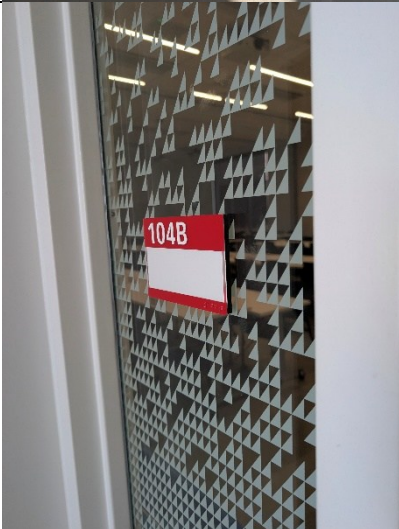
| Item | Description | Photos |
|---|---|---|
| 9 | Door identification signage with braille mounted on glazing for Room 104B. | |

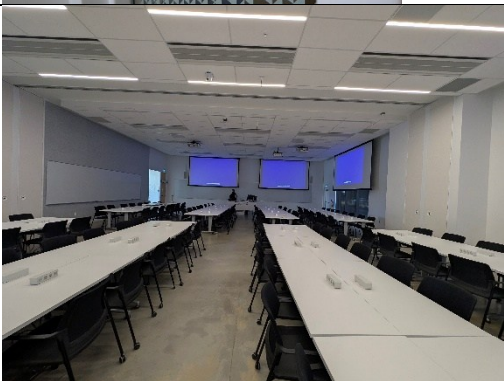
| Item | Description | Photos |
|---|---|---|
| 10 | Adjustable tables and rolling chairs with arm and back support. Tables provide direct access to power. Aisles between tables provide sufficient size and space for approach and use. | |

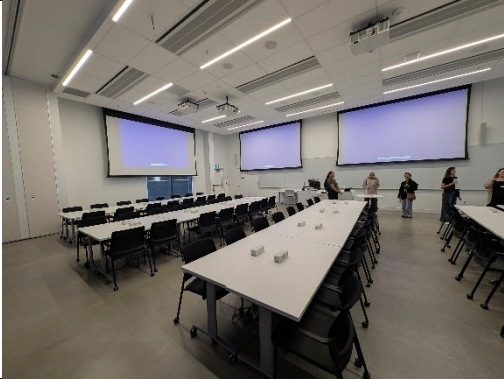
| Item | Description | Photos |
|---|---|---|
| 11 | Digital displays available on all walls. | |

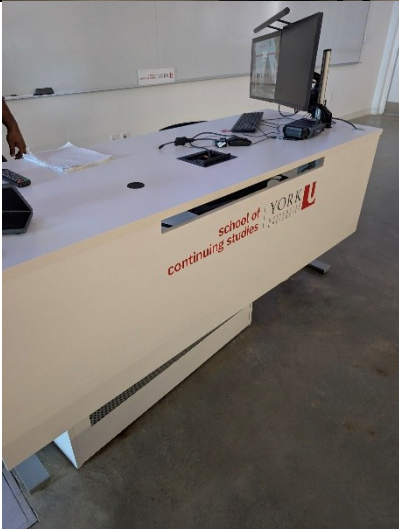
| Item | Description | Photos |
|---|---|---|
| 12 | Adjustable height lectern/podium at each end of the room. | |

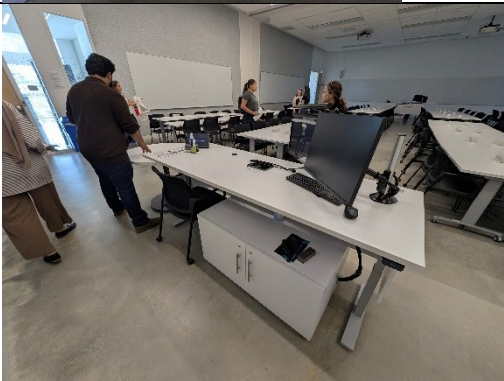
| Item | Description | Photos |
|---|---|---|
| 13 | Adjustable height lectern/podium at each end of the room. | |

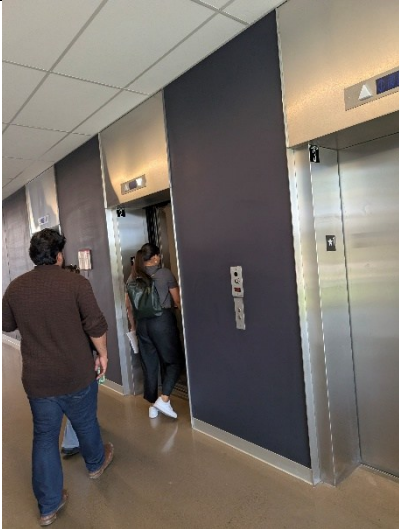
| Item | Description | Photos |
|---|---|---|
| 14 | Elevator with access to basement level. | |

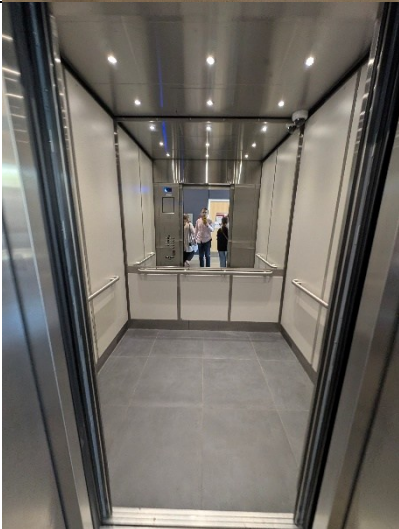
| Item | Description | Photos |
|---|---|---|
| 15 | Elevator cab. | |

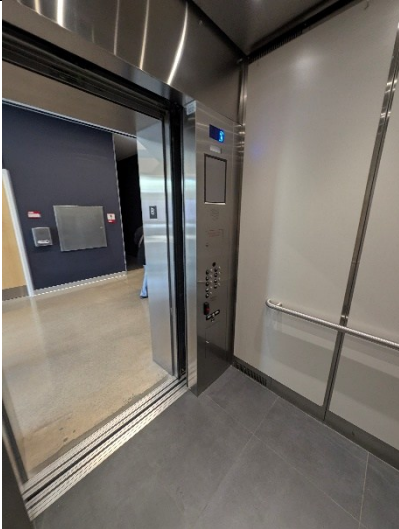
| Item | Description | Photos |
|---|---|---|
| 16 | Elevator cab with view toward lobby. | |

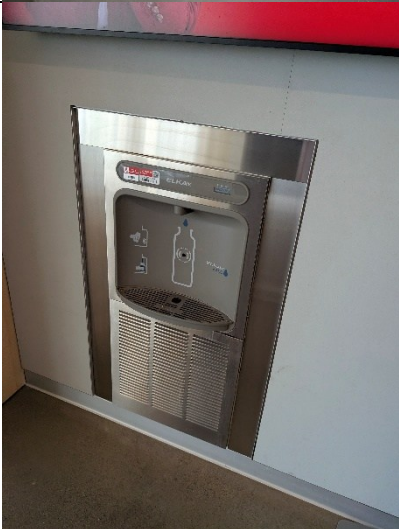
| Item | Description | Photos |
|---|---|---|
| 17 | Accessible water bottle filling station located at basement level. | |

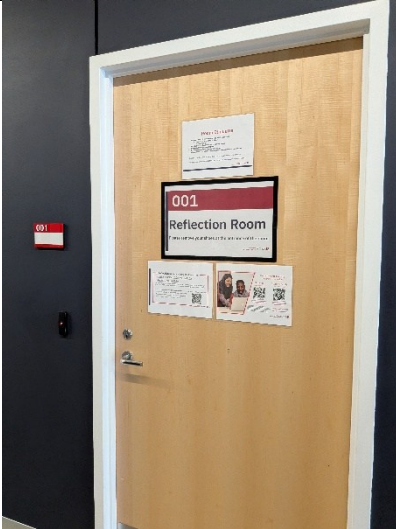
| Item | Description | Photos |
|---|---|---|
| 18 | Reflection room available at basement level. | |

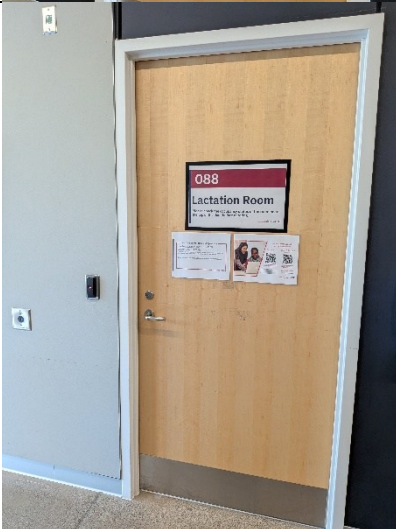
| Item | Description | Photos |
|---|---|---|
| 19 | Lactation room available at basement level. | |

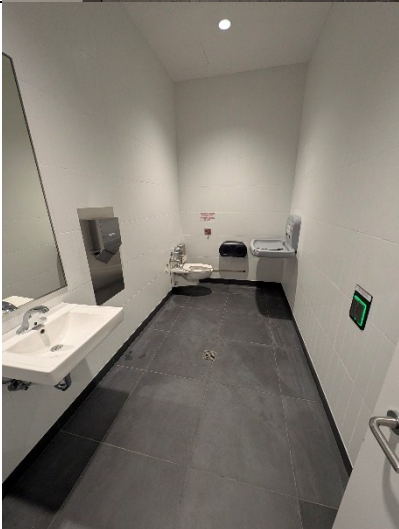
| Item | Description | Photos |
|---|---|---|
| 21 | Single occupancy barrier-free washroom available at basement level. Note that grab bars are not provided. | |

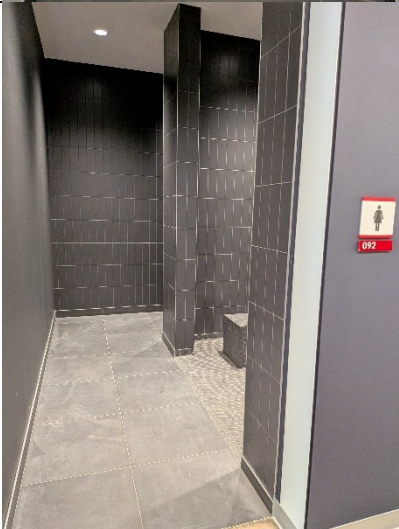
| Item | Description | Photos |
|---|---|---|
| 23 | Barrier-free women's washroom available at basement level. Assume also available at ground level. | |

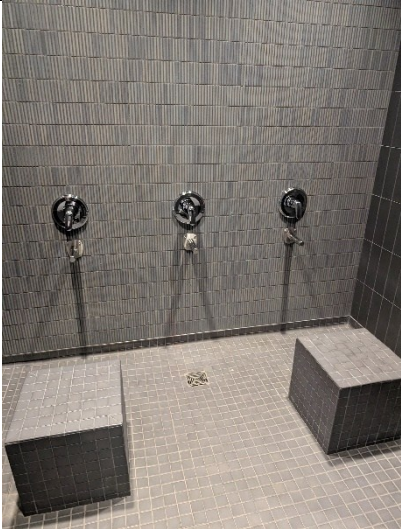
| Item | Description | Photos |
|---|---|---|
| 24 | Ablution space available within each gender designated washroom available at basement level. | |

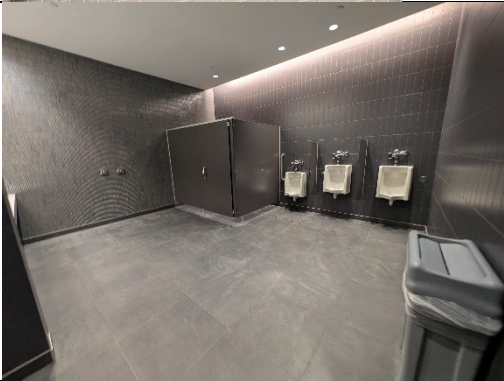
| Item | Description | Photos |
|---|---|---|
| 25 | Barrier-free men's washroom available at basement level showing barrier-free water closet stall and barrier-free urinals. | |

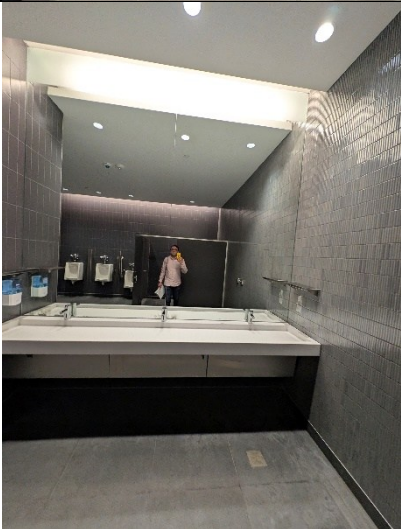
| Item | Description | Photos |
|---|---|---|
| 26 | Barrier-free men's washroom available at basement level showing barrier-free lavatories. | |

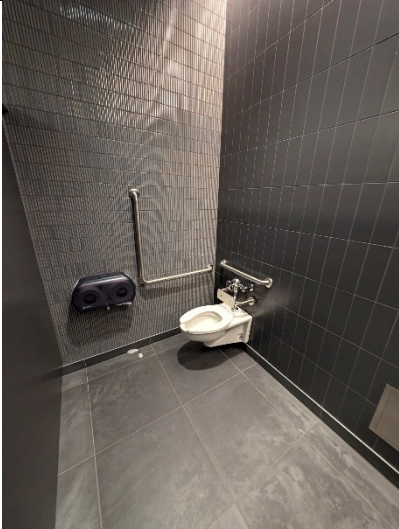
| Item | Description | Photos |
|---|---|---|
| 27 | Barrier-free men's washroom available at basement level showing barrier-free water closet stall. | |

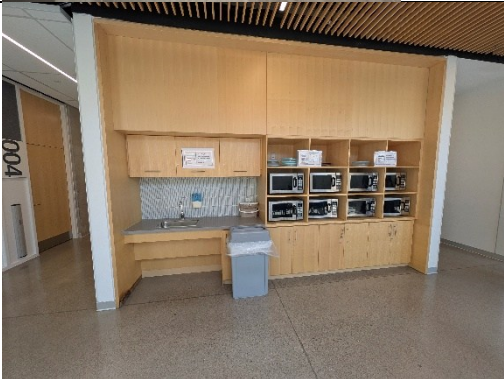
| Item | Description | Photos |
|---|---|---|
| 28 | Barrier-free kitchenette available at basement level. | |

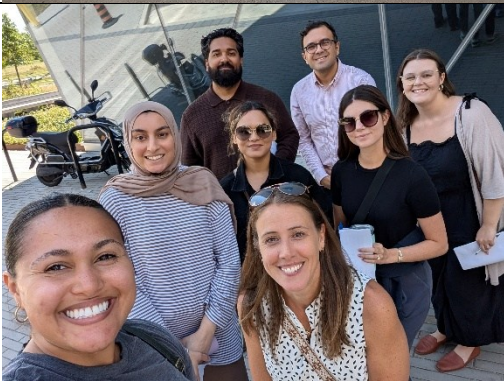
| Item | Description | Photos |
|---|---|---|
| 29 | Photo of attendees near step-free alternative entrance to building with pick-up and drop-off in proximity to Student Services Parking Garage. | |
